TECHNICAL ASSISTANCE TEAM FOR EMERGENCY RESPONSE REMOVAL AND PREVENTION
EPA CONTRACT 62-01-6669MEMORANDUM

SUBJECT: Preliminary Assessment - Schaffer Electric Company
PCB Site in Minden, West Virginia

RE: Schaeffer Electric Site Assessment

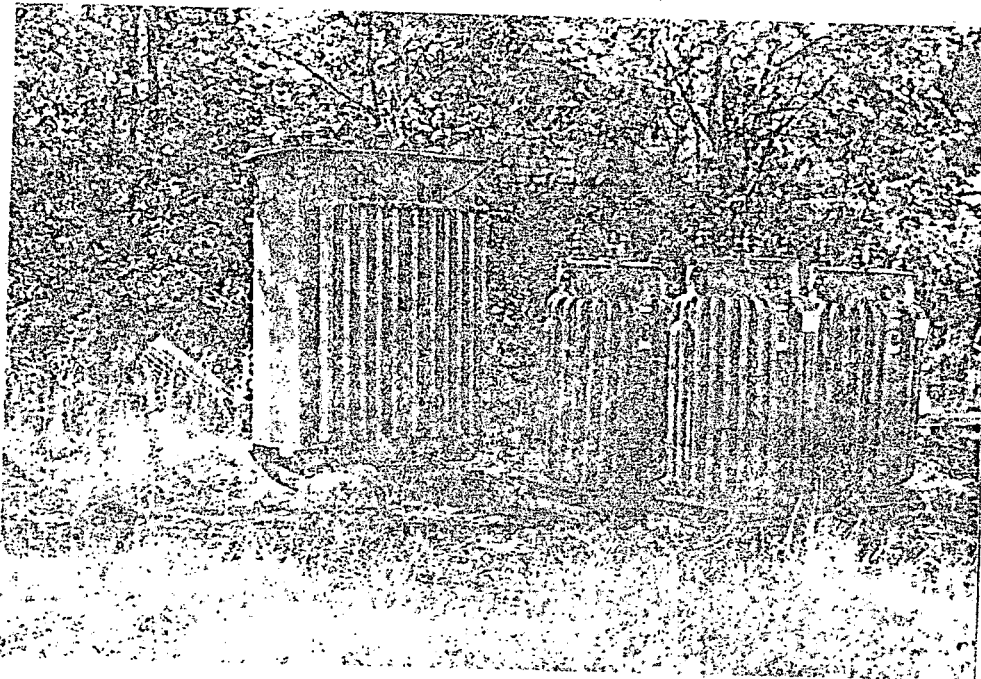
2. Large transformers in Area A are stacked on pallets.

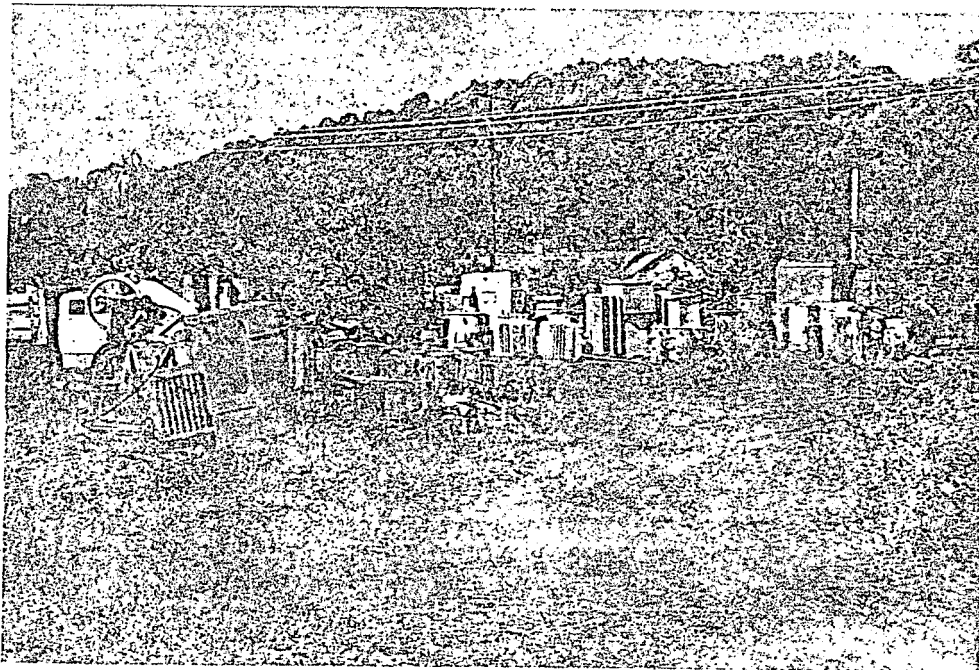
4. CLOSE-UP OF #3.

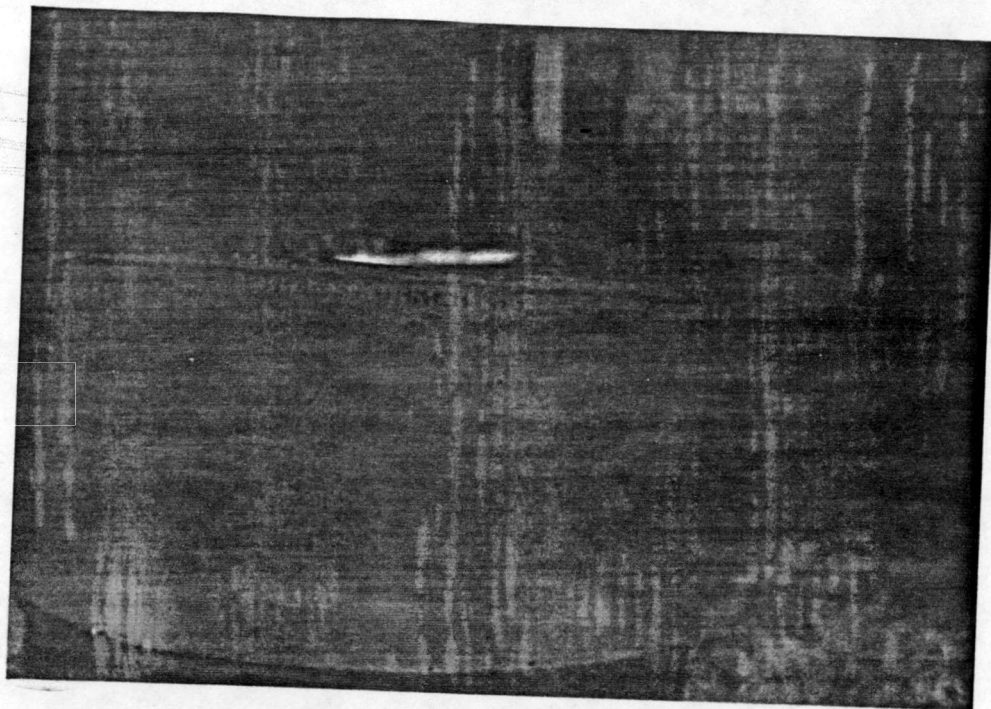
Station 01	2.0 ppm	PCB (Aroclor 1260)
Station 02	147.0 ppm	PCB (Aroclor 1260)
Station 03	5.7 ppm	PCB (Aroclor 1260)

Photo #1 "Transformer 55" (Station 01)
Drum marking indicating transformer fluids.

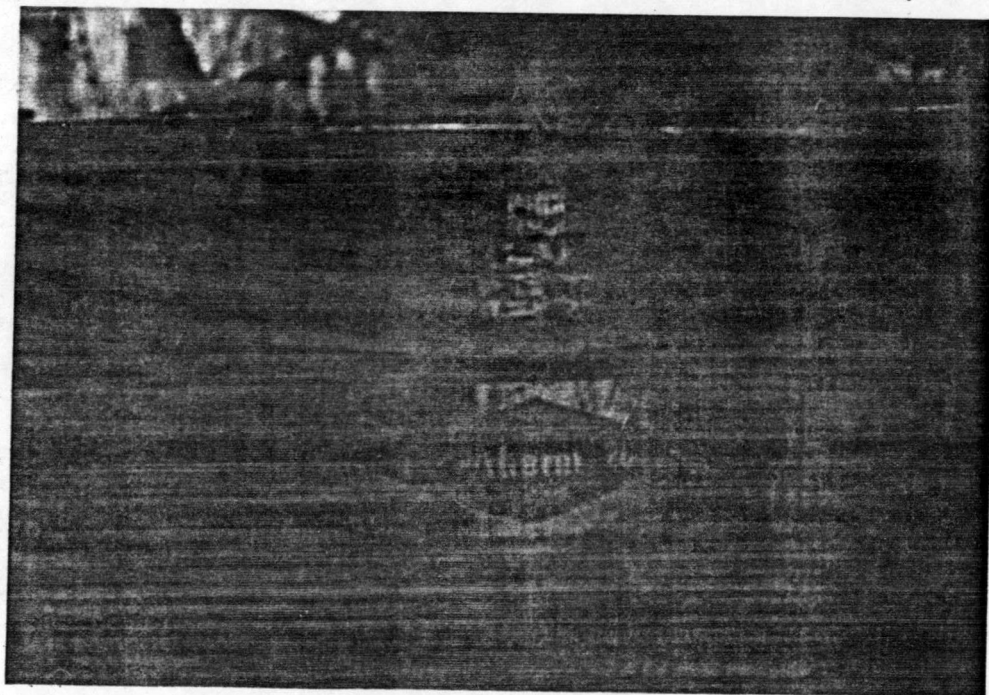
As a result of this analysis, Station 02 was identified as a PCB product. The other 2 drum samples will be analyzed for the full priority pollutant analysis to identify the contents of the drums.

Photo #2 Dowtherm 209 (Station 02)
Coolant
PCB (Archlor) indicated 147 ppm.

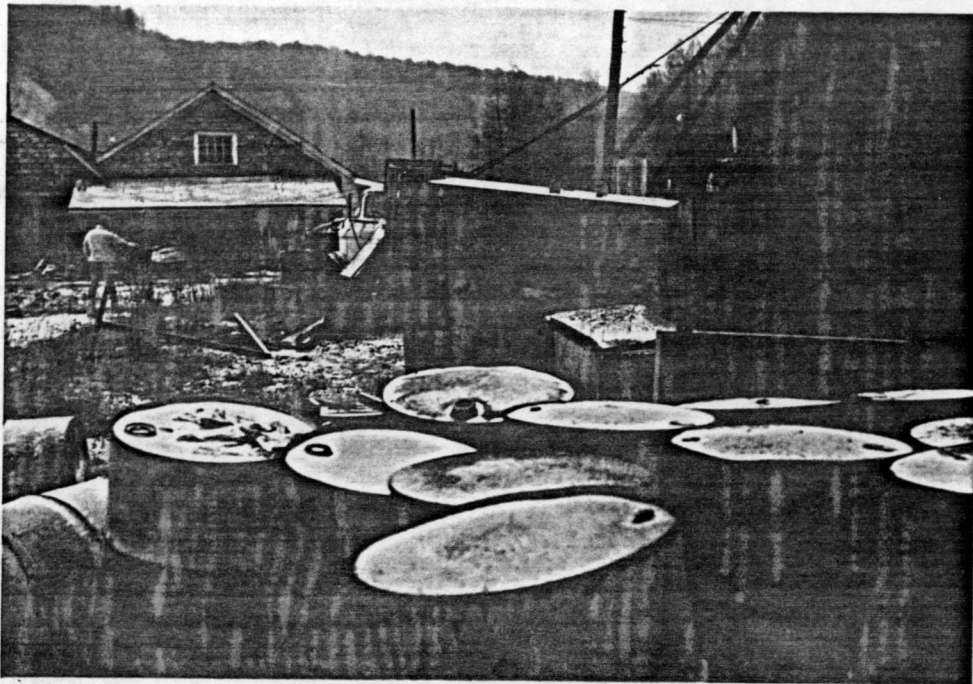
Photographs of the drums and the assessment are attached for reference. In addition, a site sketch indicating the locations of the photographs has been included. Painted markings on drum #1 was "Transformer #55". Drum #2 (which may have been reused) was labeled Dow "Dowtherm 209 Coolant". Drum #3 was bulging on both ends, and no markings were apparent.

Photo 3: Bulging drum (Station 03)
PCB analysis indicated 5.7 ppm arclor.

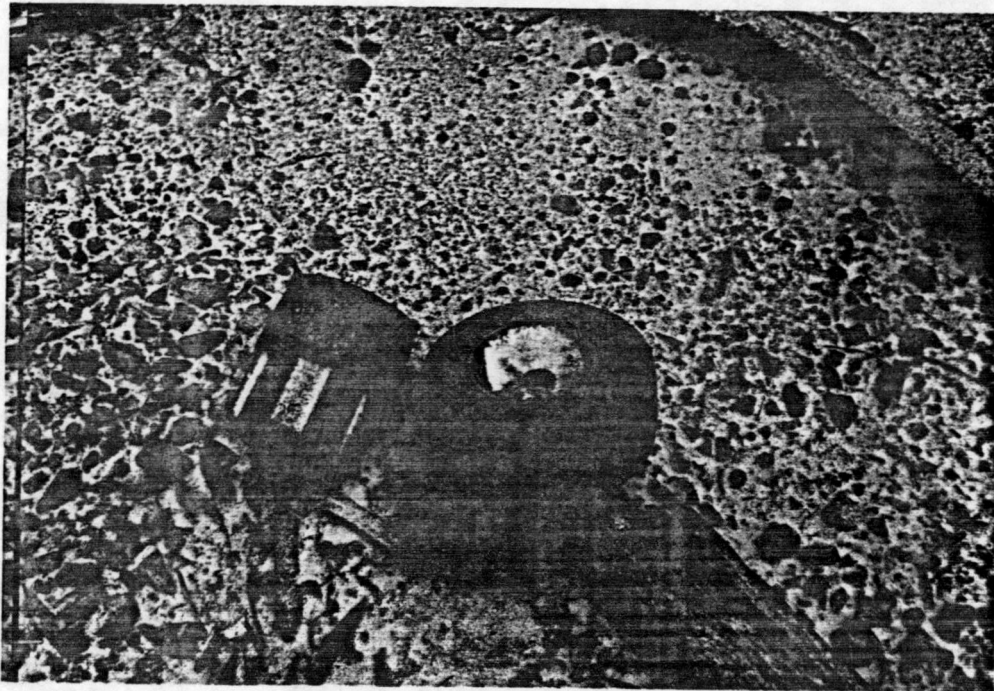
Photo 4: Children's toys on site.

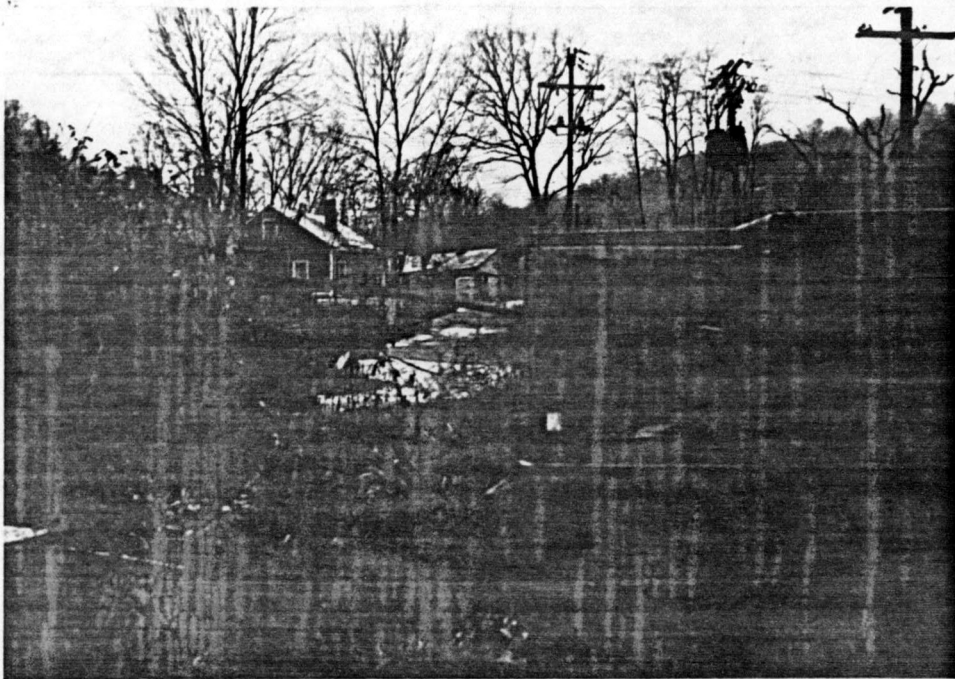
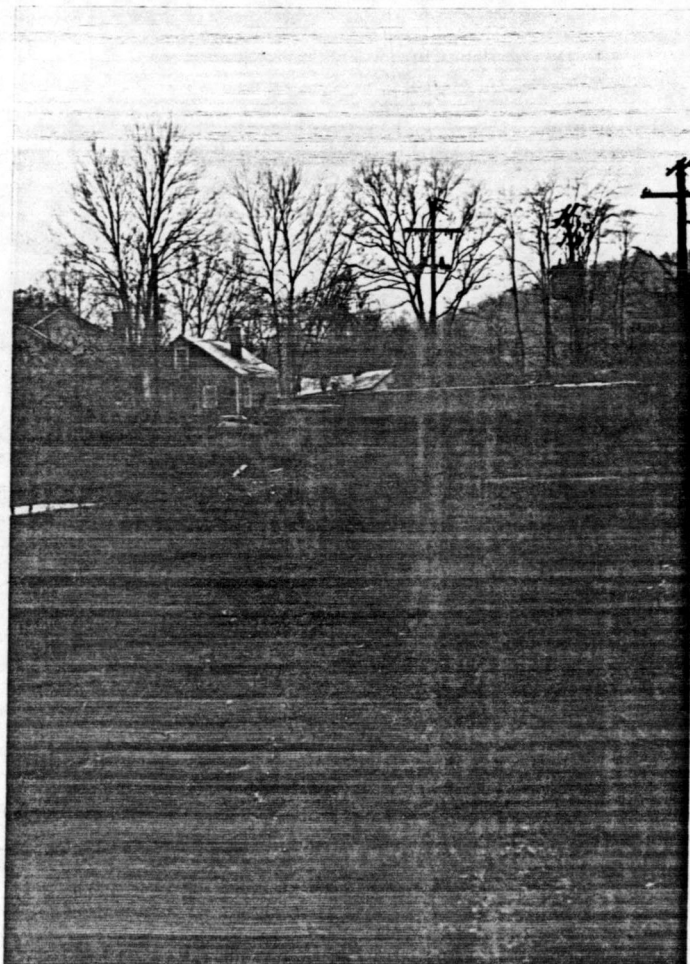
Photo 5 and 6: Pathways utilized by neighboring children as a thru-way and playground.

Close proximity of site in relation to residents.

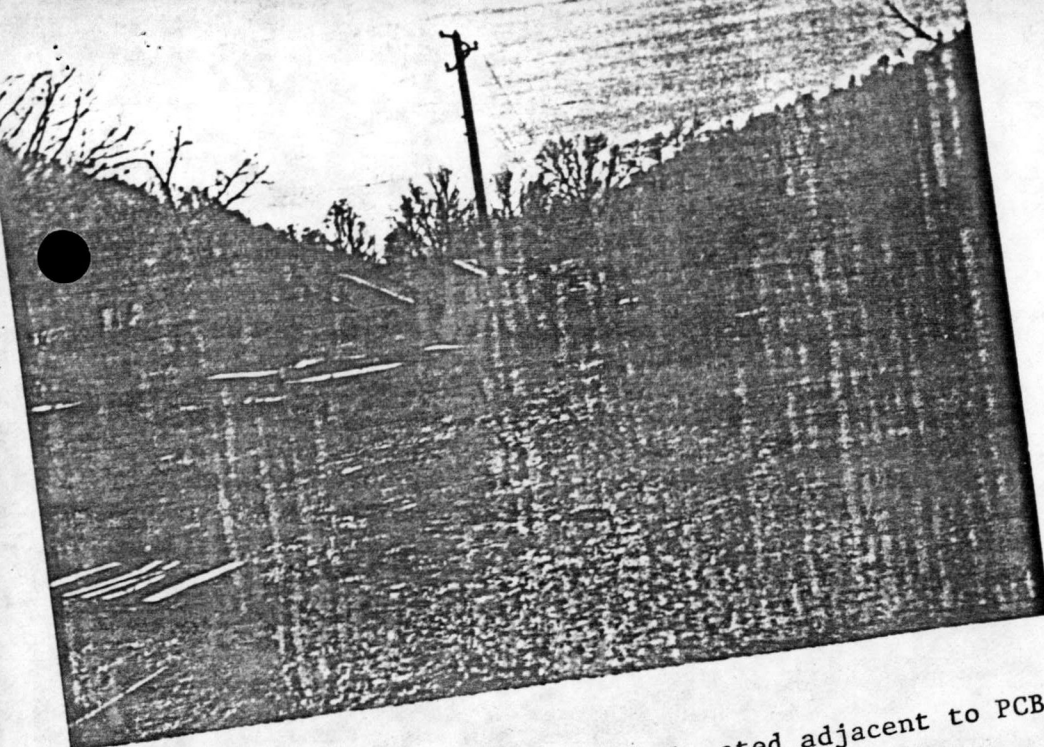
Photo #7 Residential dwellings located adjacent to PCB contaminated soils and transformers.

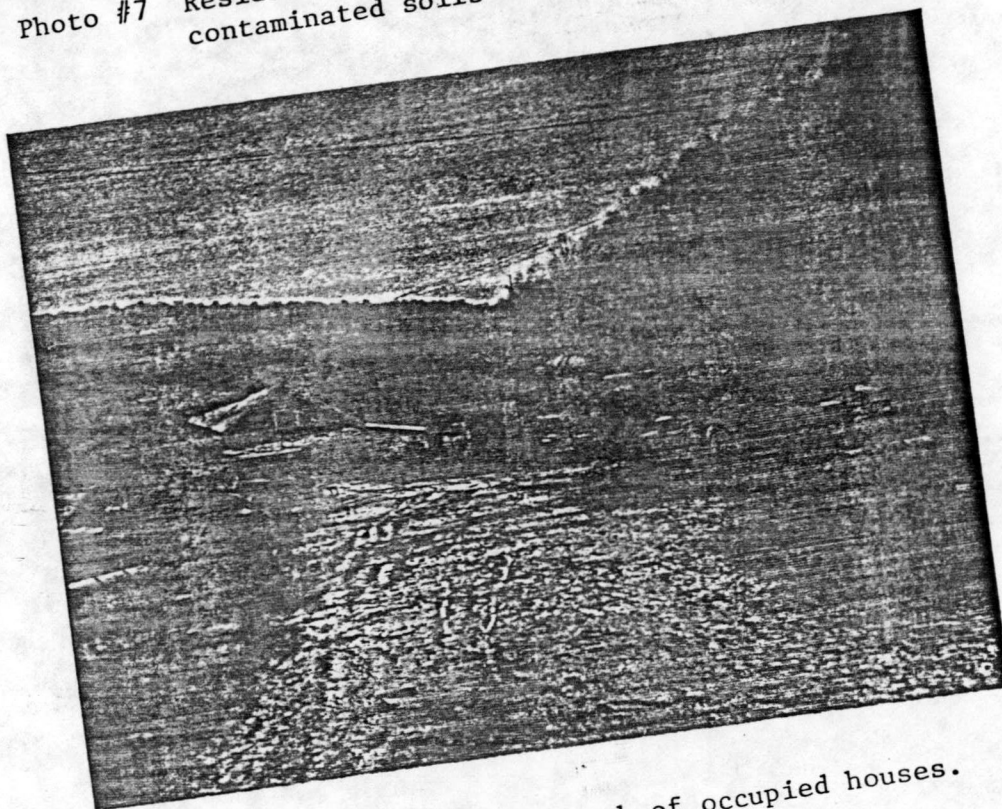
Photo #8 Office located south of occupied houses.

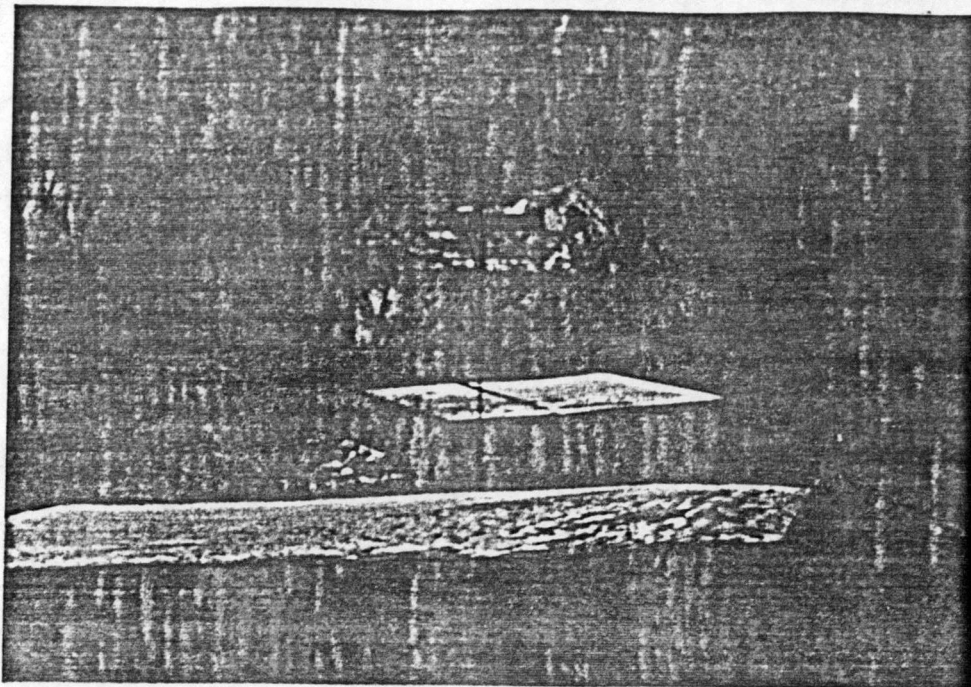
Photo #13: Capacitors casings strewn randomly on site.

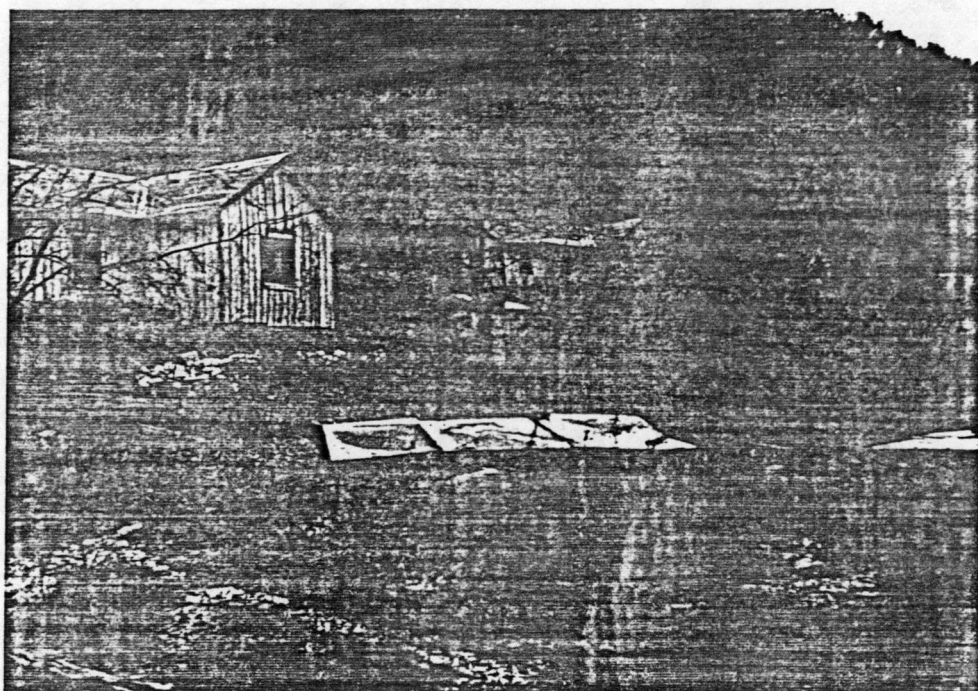
Photo #14: Capacitors casings randomly strewn on site.
A trash dump is being started and used by residents.

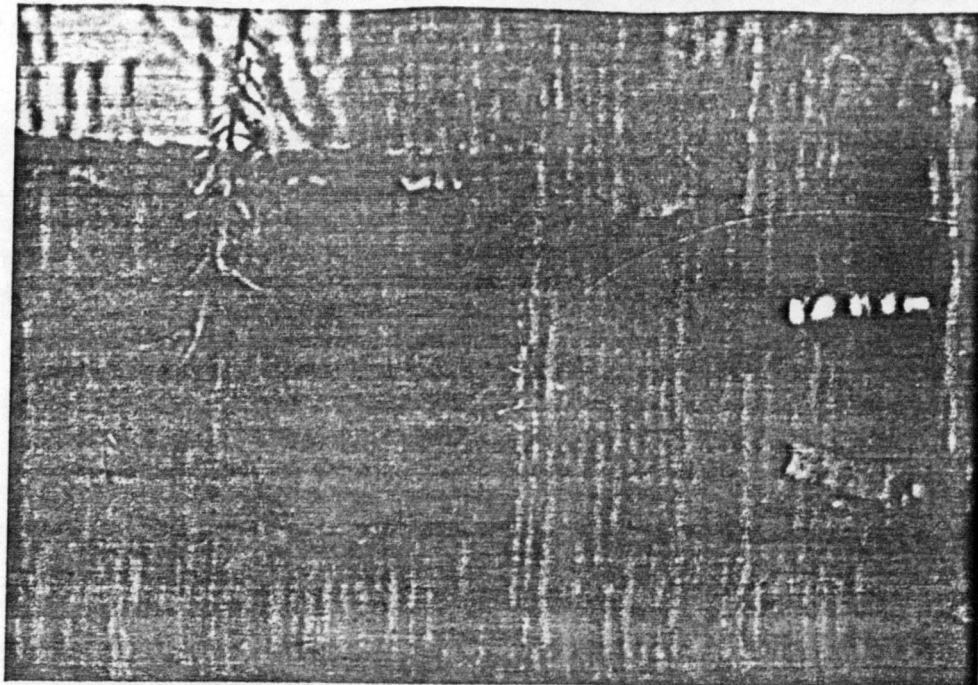
Photo #15: Sodium Nitrate/Nitrite drums are partially buried
(fertilizer)

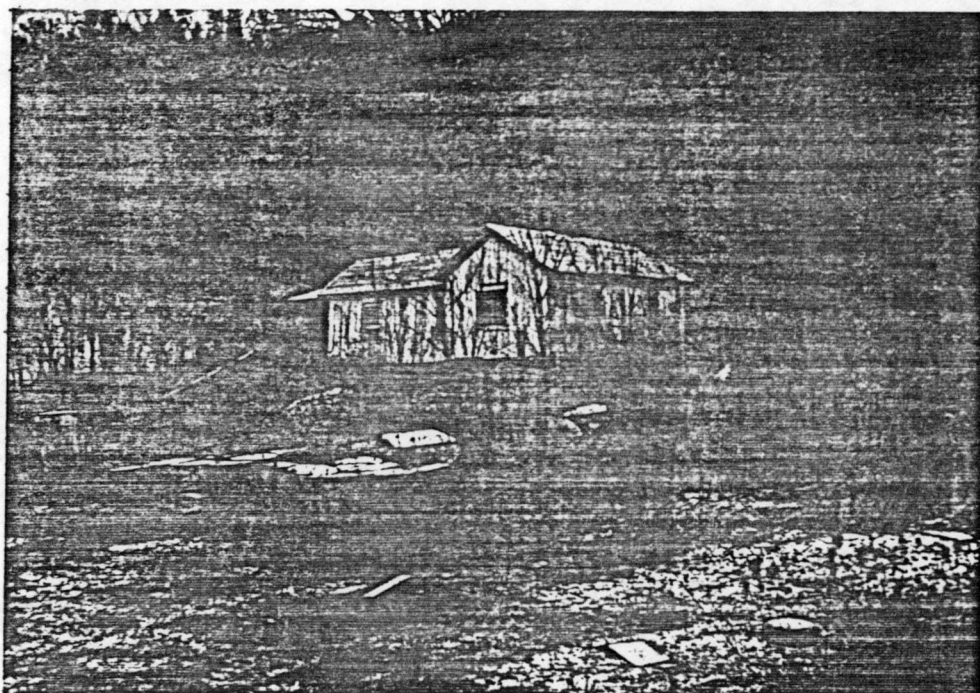
Photo #16: Miscellaneous drums accumulated on site.

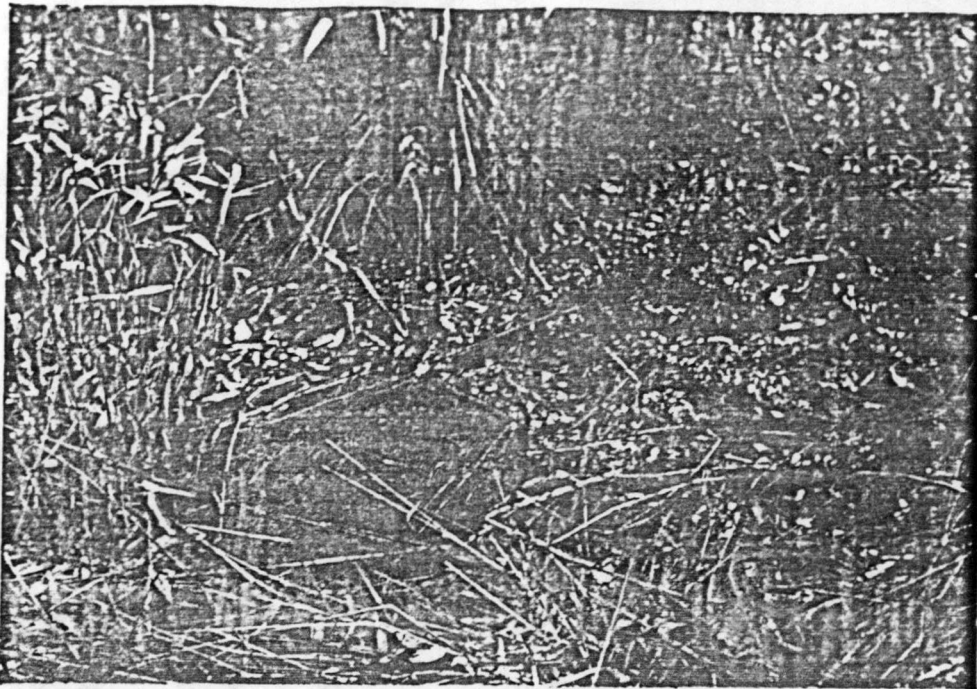
Photo #17: Oily residues in the ground.

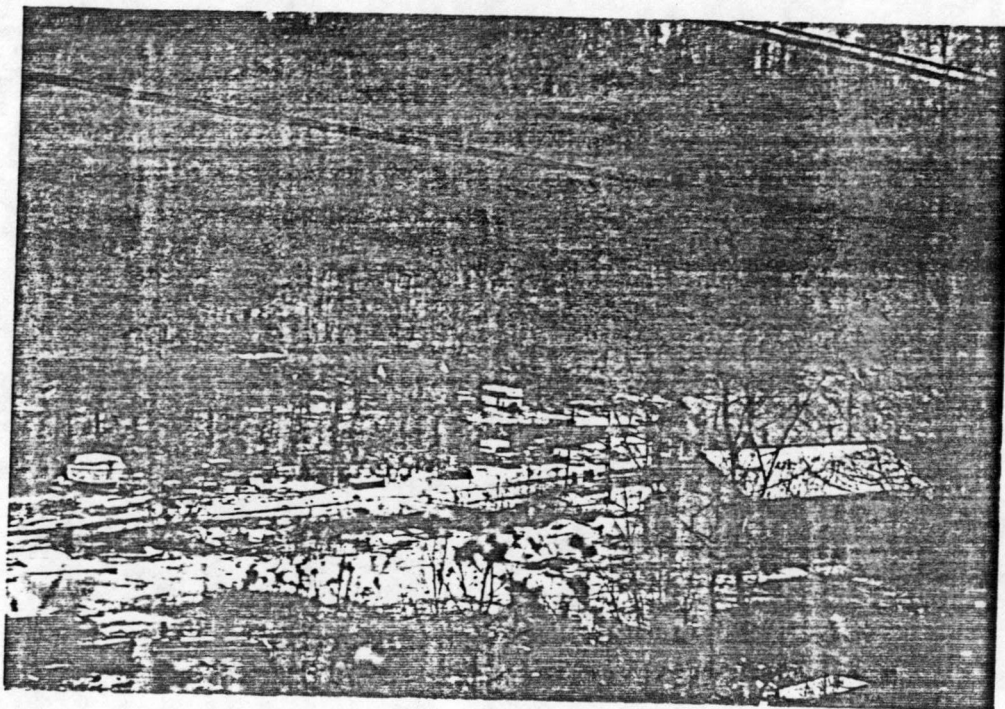
Photo #20: Site overview office, shop, good staged transformers and capacitors.

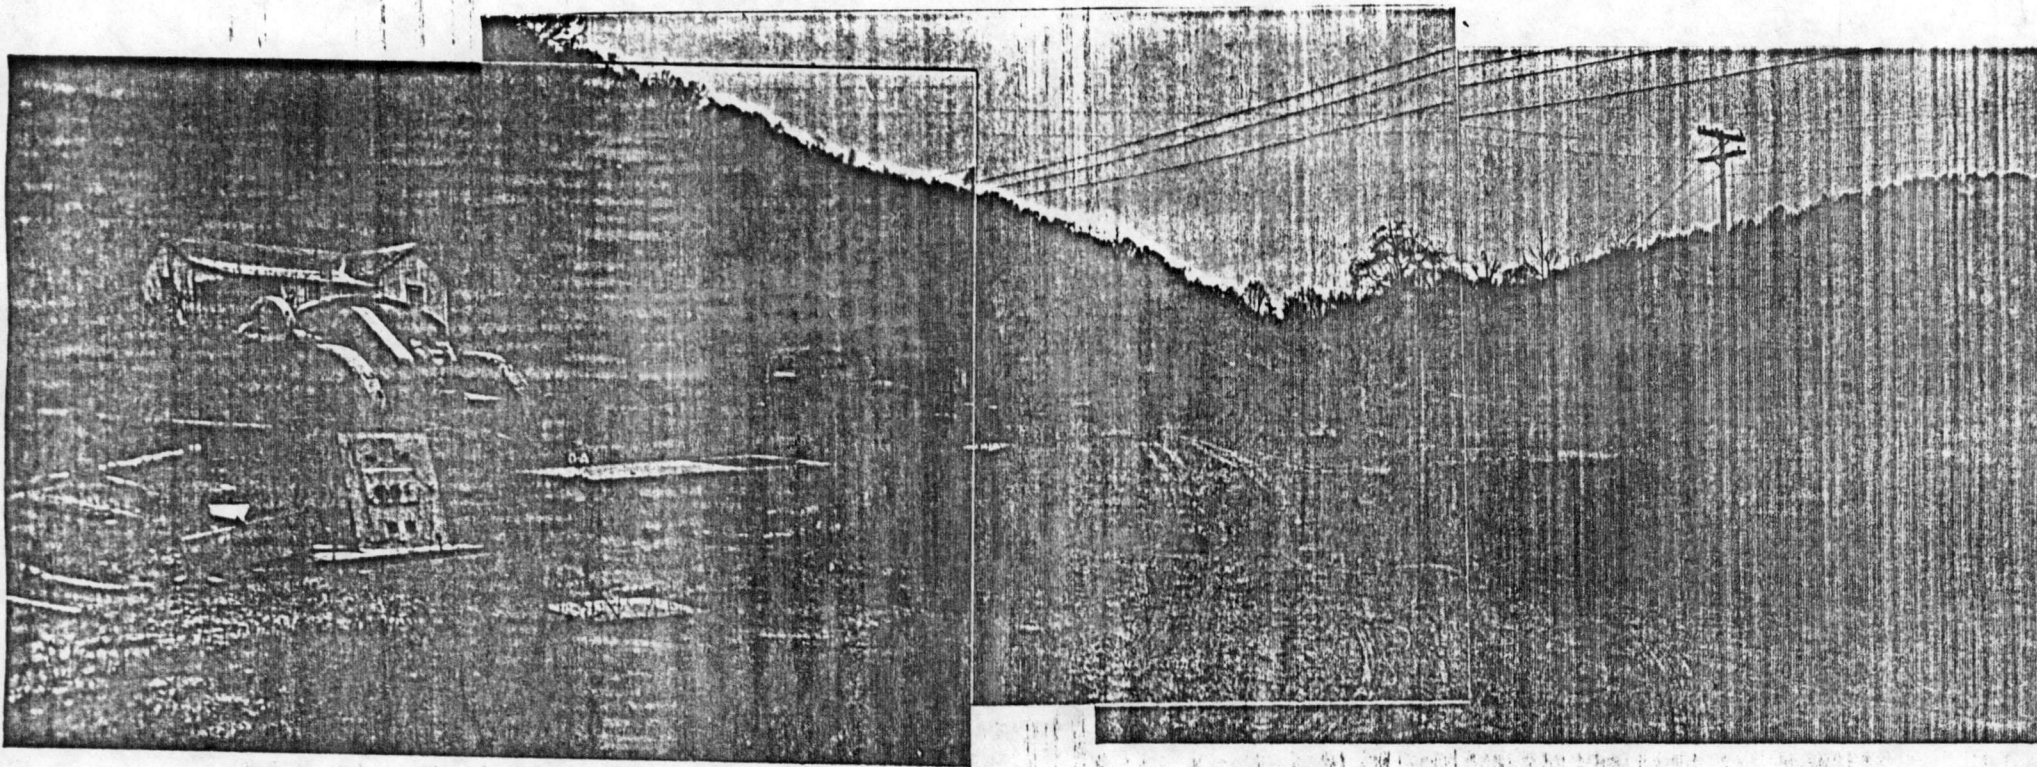
Photo 21: Wide angle overview of site. Transformers, drums, capacitors, contaminated soils, close residents.
